SPLIETHOFF'S B.V.

Customer Needs:

A high corrosion and abrasion resistant coating system. Easy to repair and to maintain while at Sea.

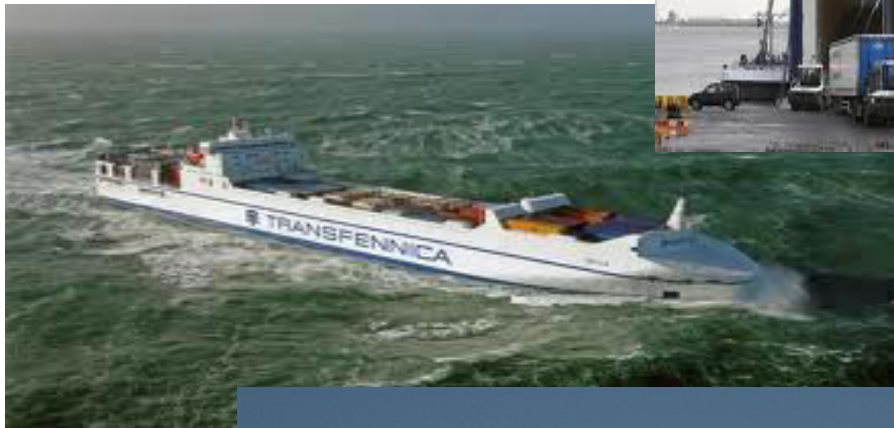
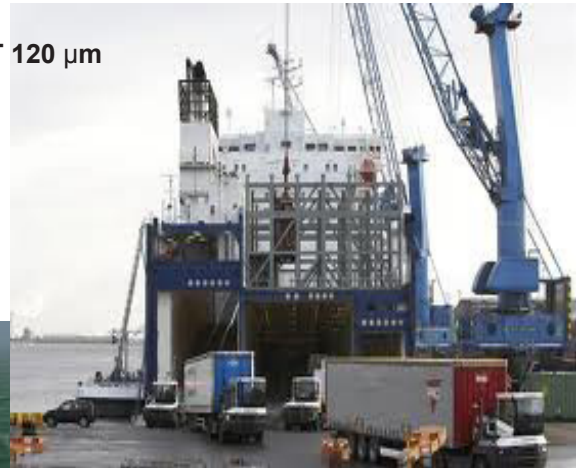
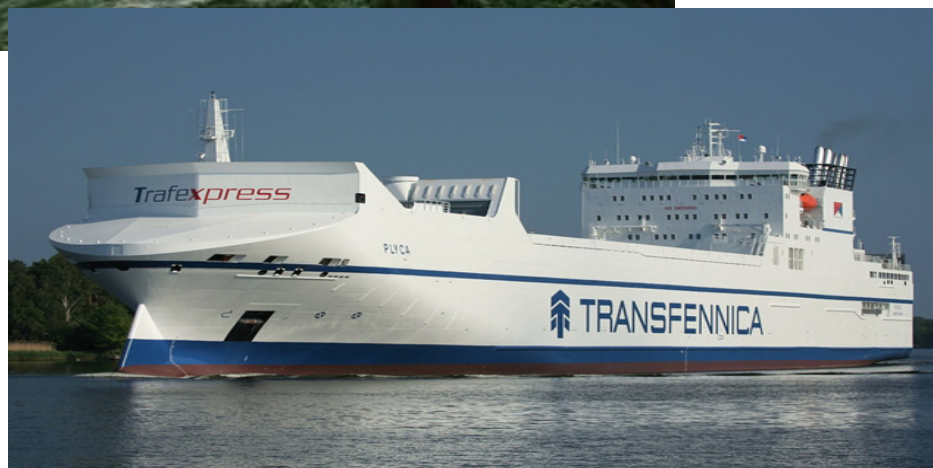
On board of the ConRo ships, the weather-decks and the loading ramps are subject to high wear.

If the wear-down coating get wet it tends to get very slippery and of course rusting of the surface occurs.

After cleaning the surfaces using handtool acc. to St.3, the treated areas were coated to full satisfaction with a Unica System:

| 1. Primer | Uni-Micazinc MC Grey | DFT 75 µm |
| 2. Intermediate | Uni-Aluprotector

with Aluminium NON-skid,
(if necessary) | DFT 120 µm |

| 3. Topcoat | Uni-Aluprotector | DFT 120 µm |
