WAGENBORG SHIPPING B.V.

CASE STUDY

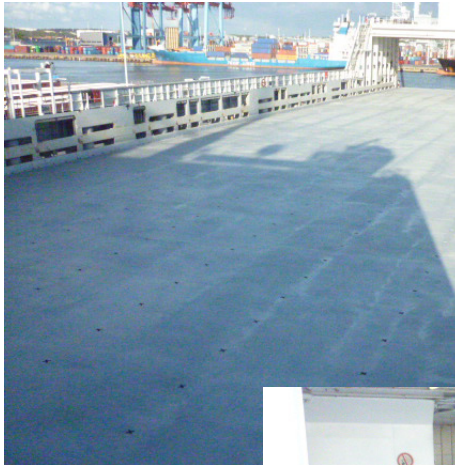
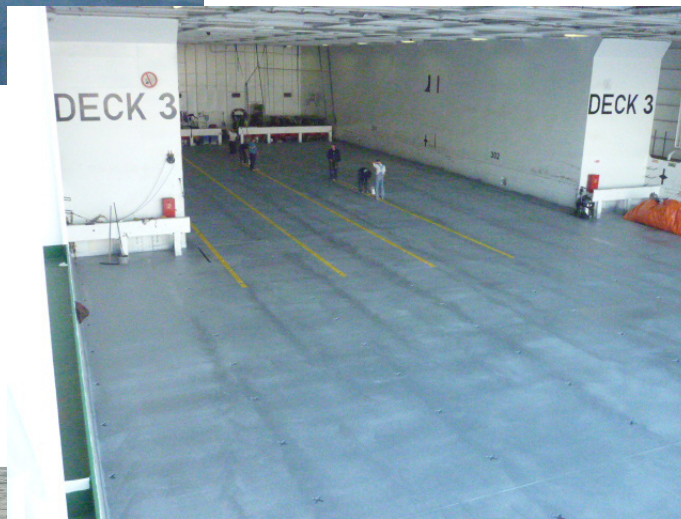
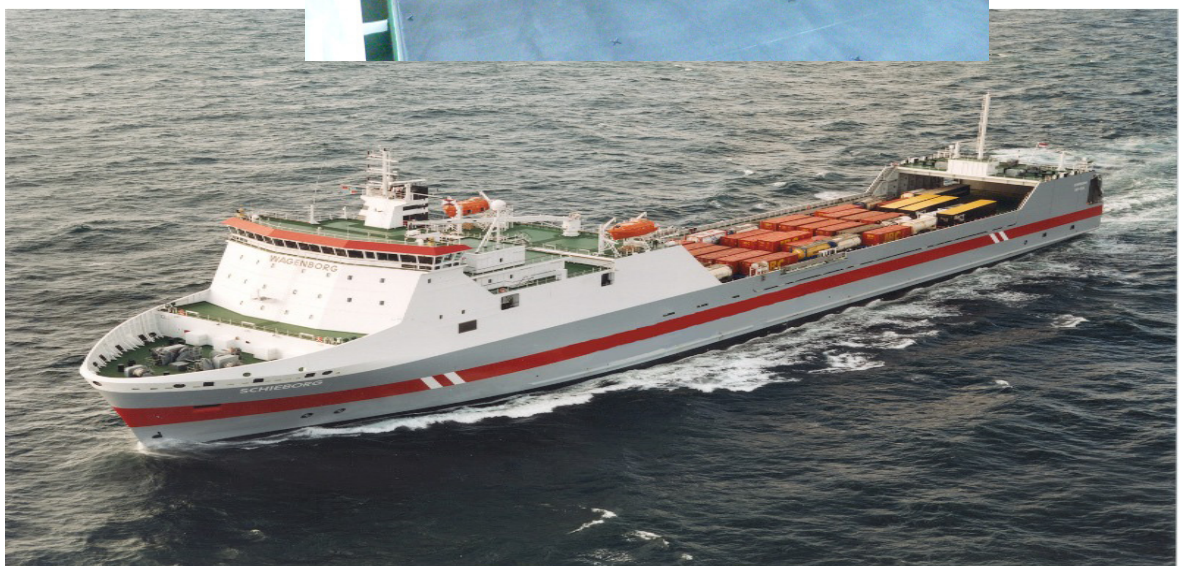
On board of the RoRo ships, the weather-decks and the loading ramps are subject to high wear.

If the wear-down coating get wet it tends to get very slippery and of course rusting of the surface occurs.

After having completed surface preparation (Blas-trac to Sa-2), the treated areas were coated to full satisfaction with a Unica System:

| 1. Primer | Uni-Micazinc MC Grey | DFT 75 µm |
| 2. Intermediate | Uni-Aluprotector

with Aluminium NON-skid | DFT 120 µm |

| 3. Topcoat | Uni-Aluprotector | DFT 120 µm |
